CALSPAN LIMITED ON-SITE AIR BAG DEPLOYMENT INVESTIGATION

CALSPAN CASE NO. 91-1

FLEET - 1988 ACURA LEGEND LS

LOCATION - [REDACTED], OH

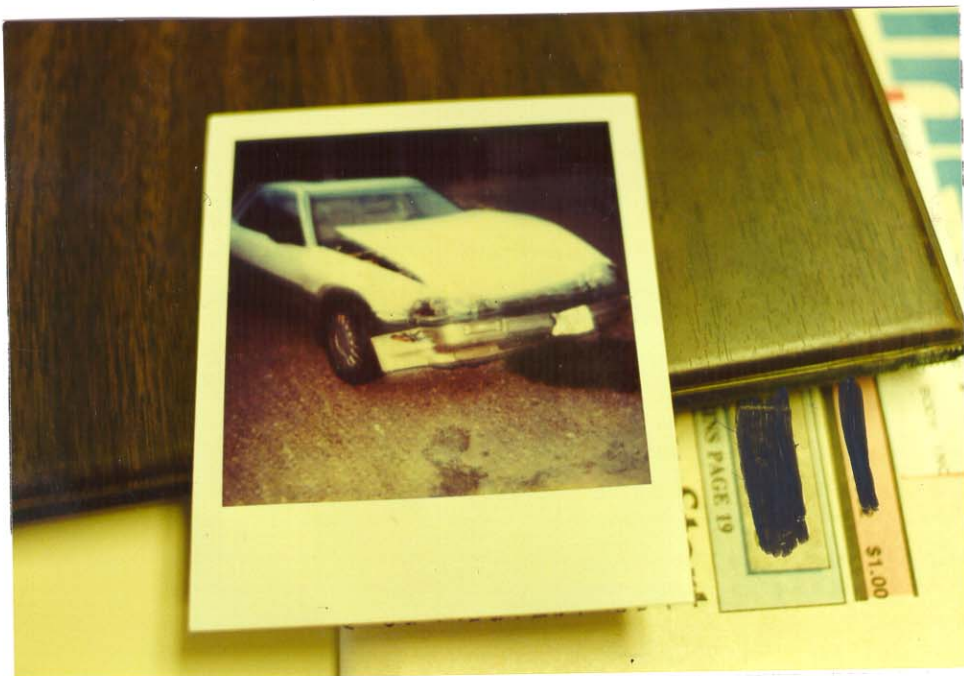
Frontal Damage To The Acura Legend

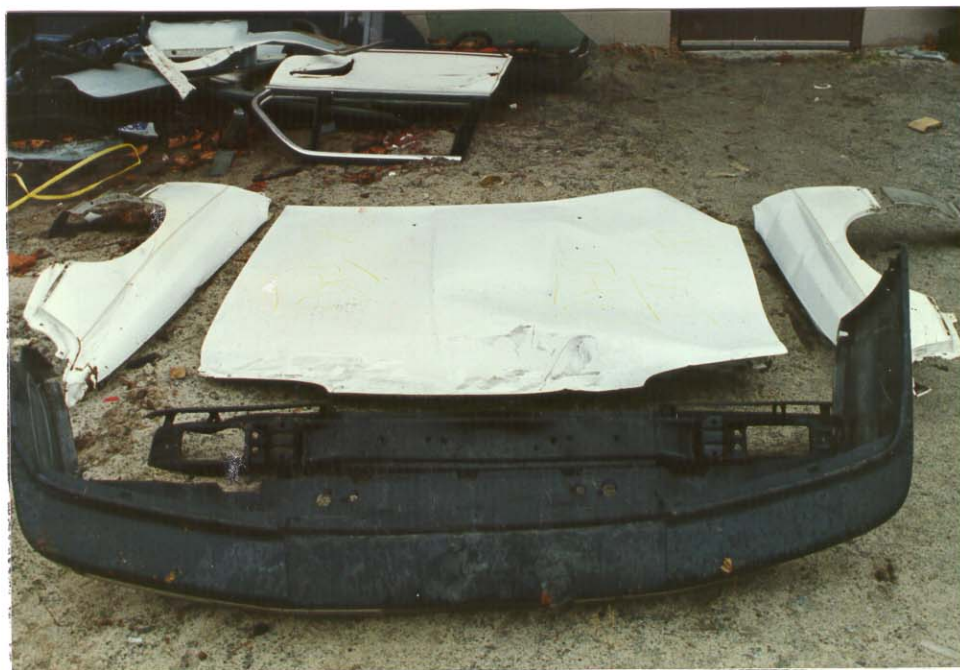
Damaged And Replaced Frontal Components

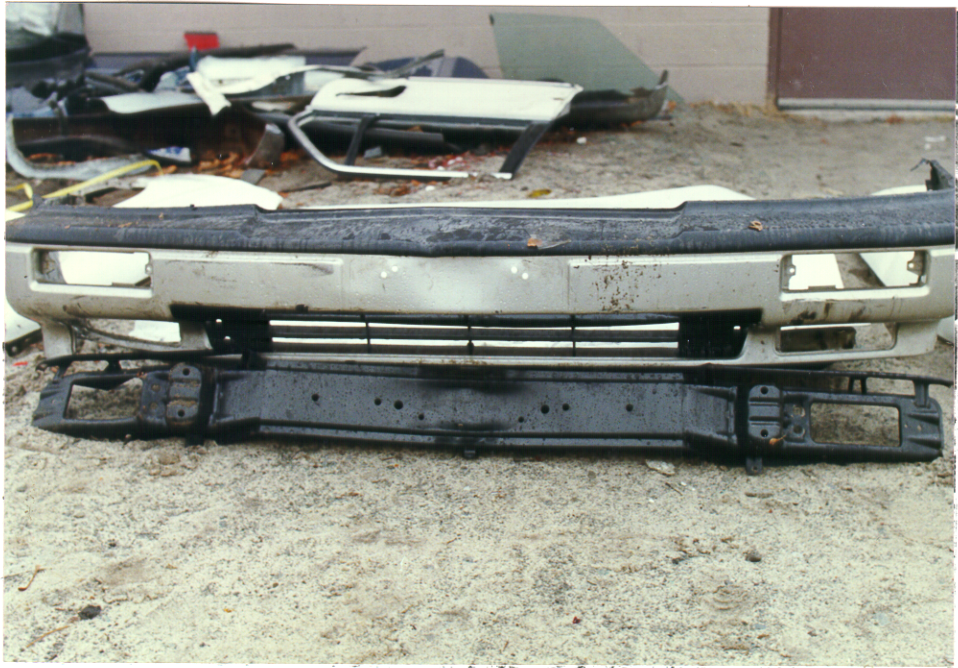
Damage To The Bumper Facia And Reinforcement Bar

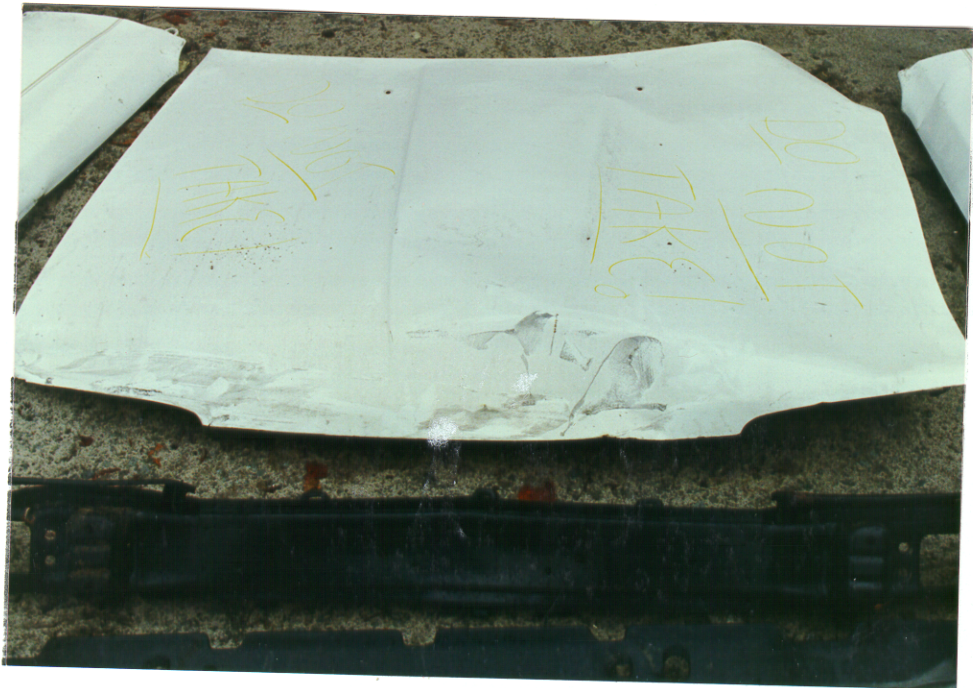
Hood Damage

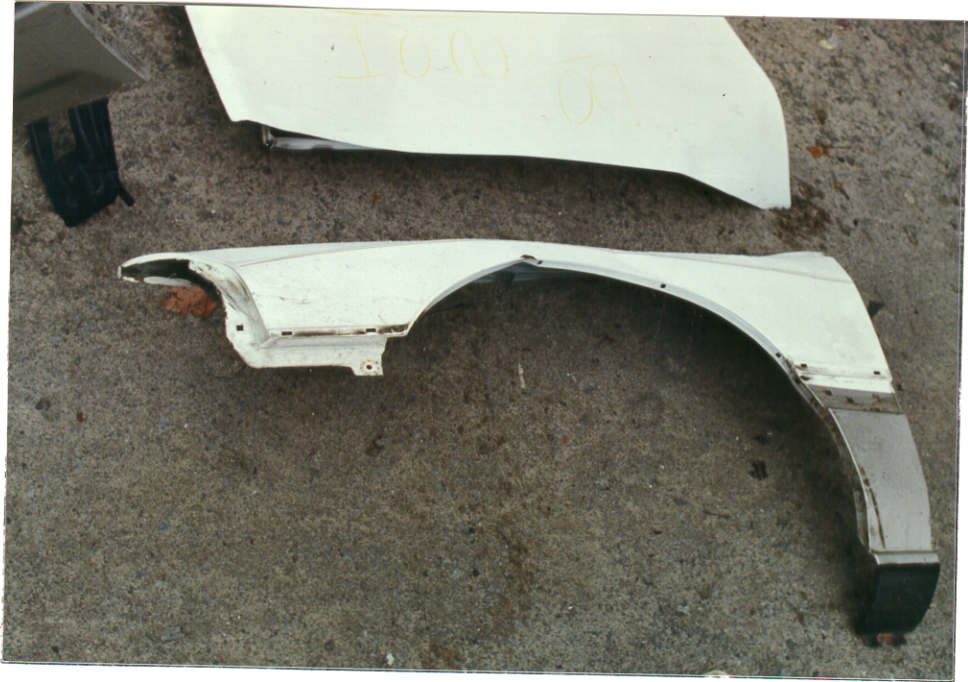
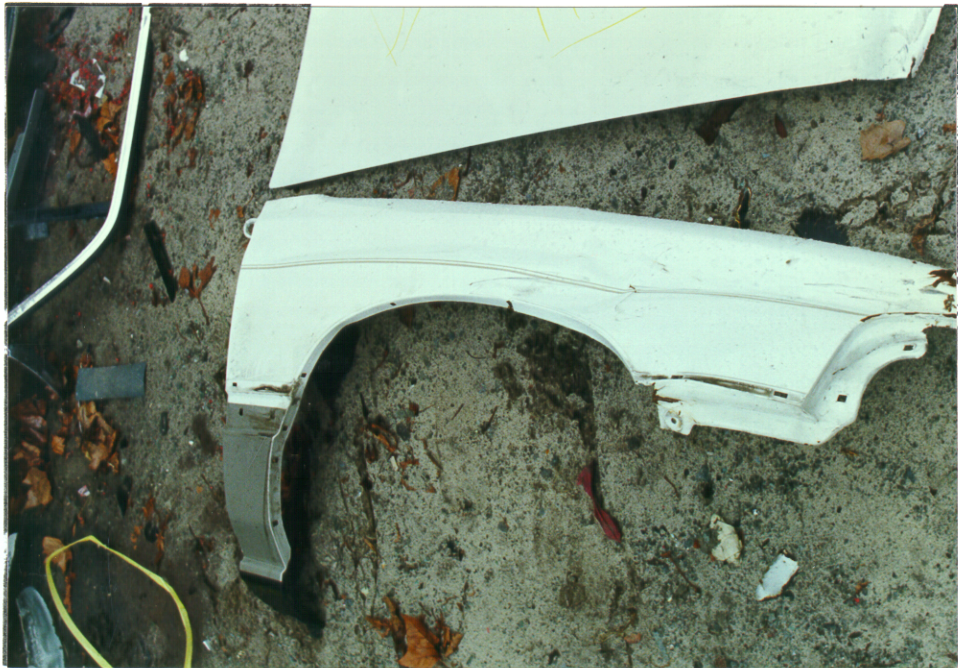
Damaged Front Fenders

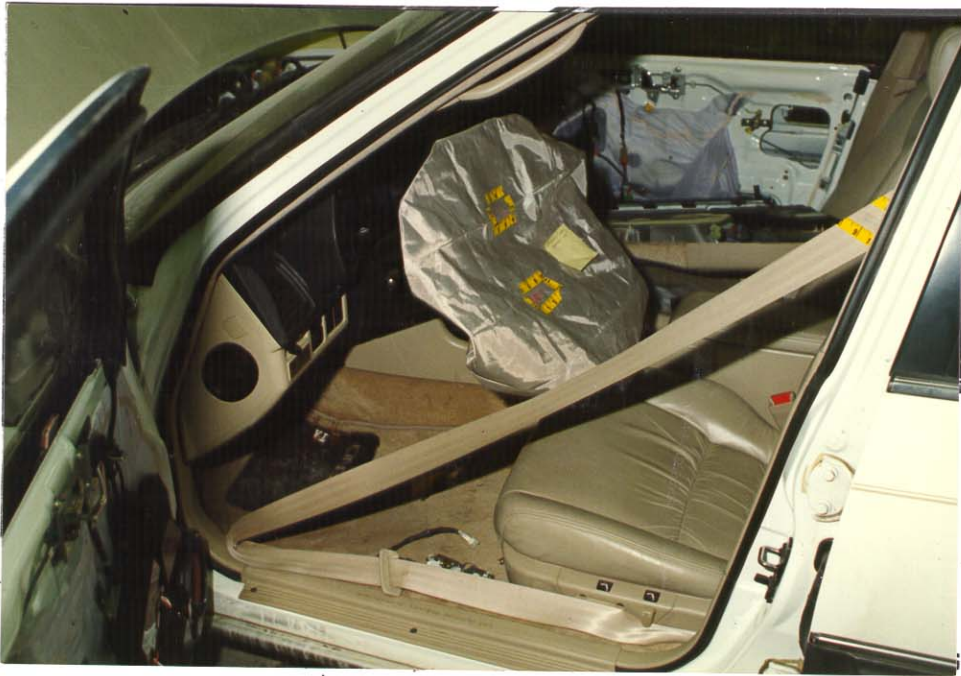
Overall Interior View Of The Deployed Air Bag
And Active 3-Point Belt, Webbing

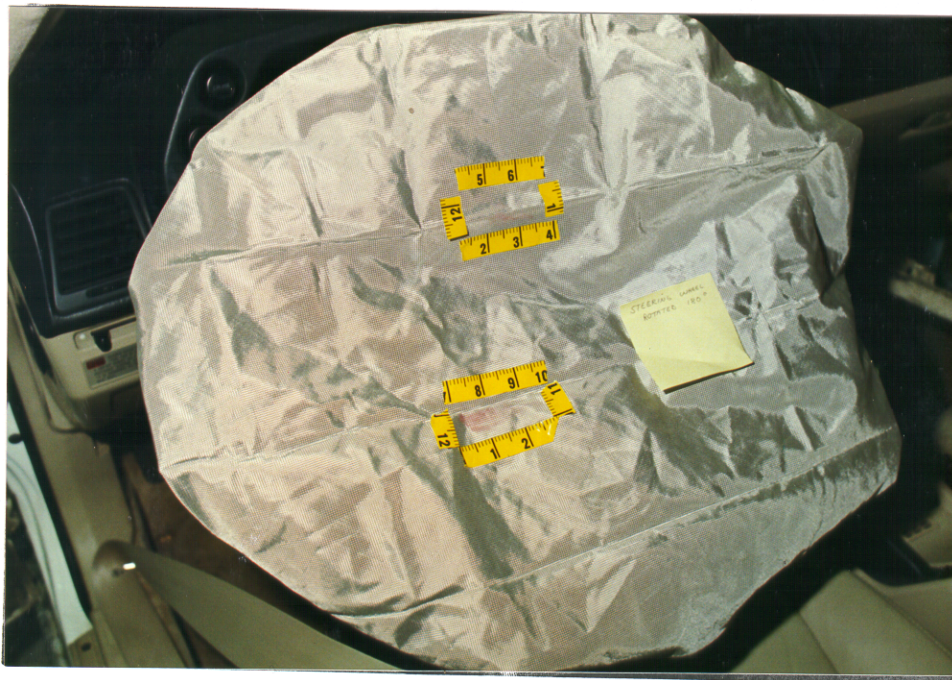
Interior (Air Bag Vehicle) (Cont'd.): deployed air bag depositing lipstick and suspected makeup transfers on the face of the bag. The lipstick transfer was located 0-.75" below the horizontal centerline and 1-3" left of the vertical centerline. The makeup transfer (possible eye makeup) extended 4.75 - 5.5" above and .5" right to 1" left of the reference centerlines. All measurements were taken with the steering wheel rotated 180° from a straight ahead position.

Driver Facial Contact (Lipstick And Makeup Transfers) To The Deployed Air Bag

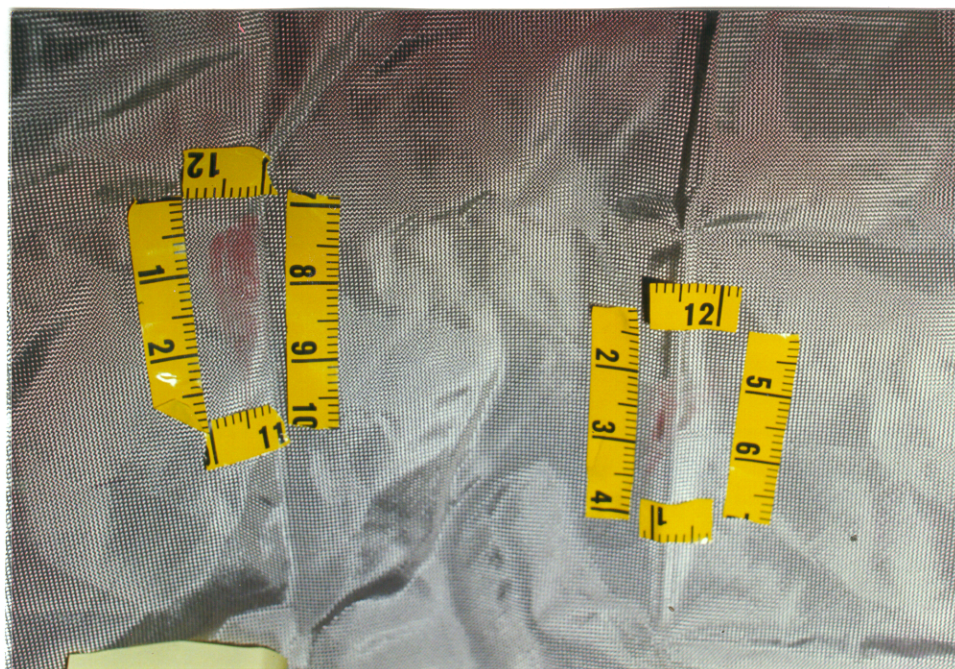
Closeup Views Of The Facial Contacts

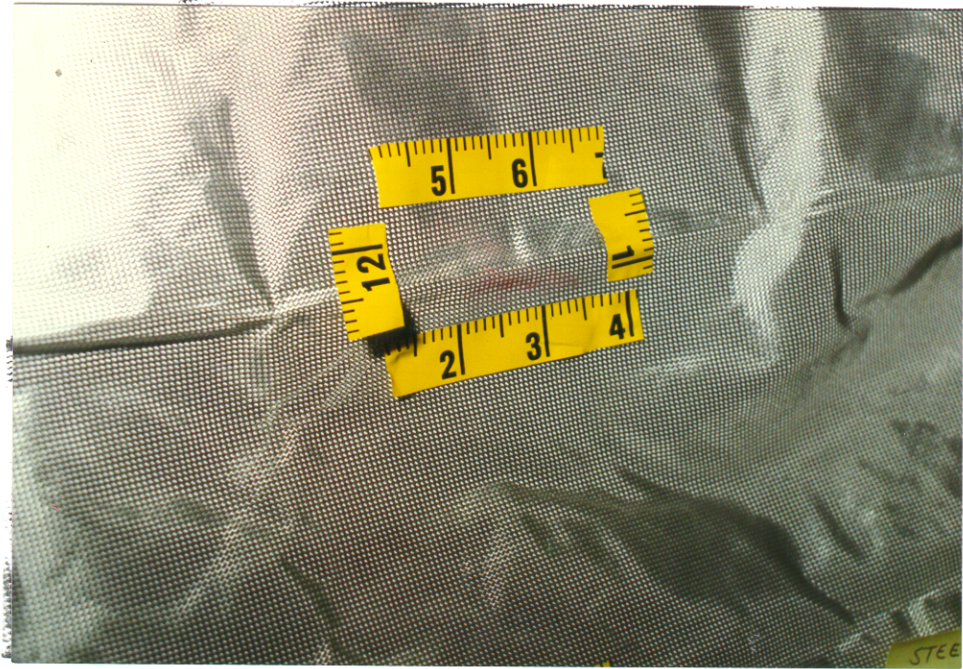
Eye Makeup Transfer On A Fold Crease

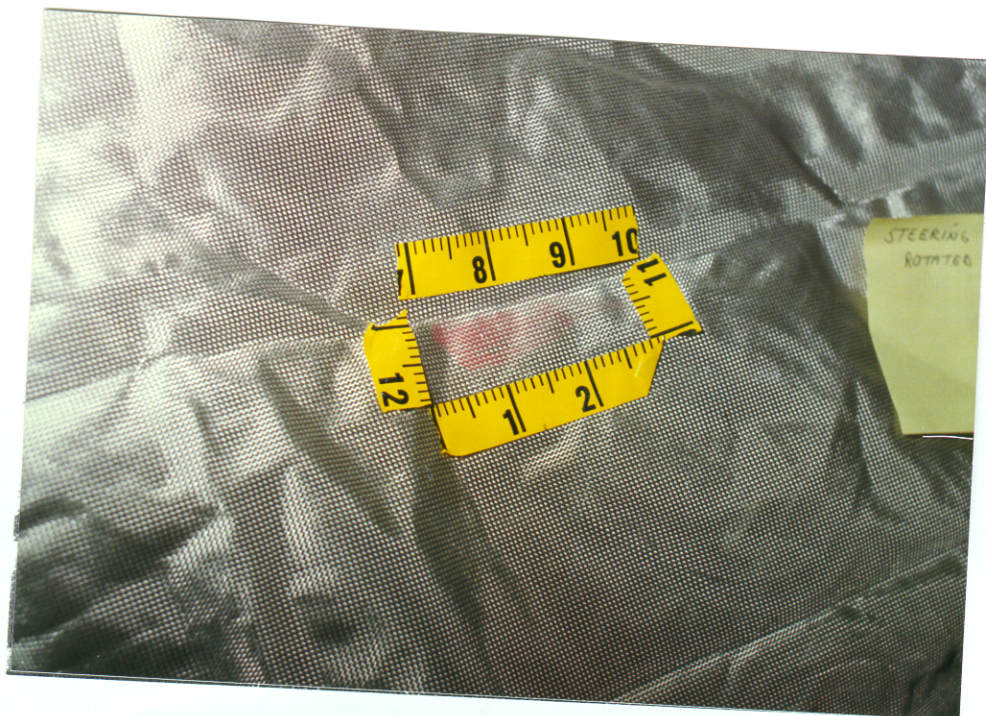
Closeup View Of The Lipstick Transfer

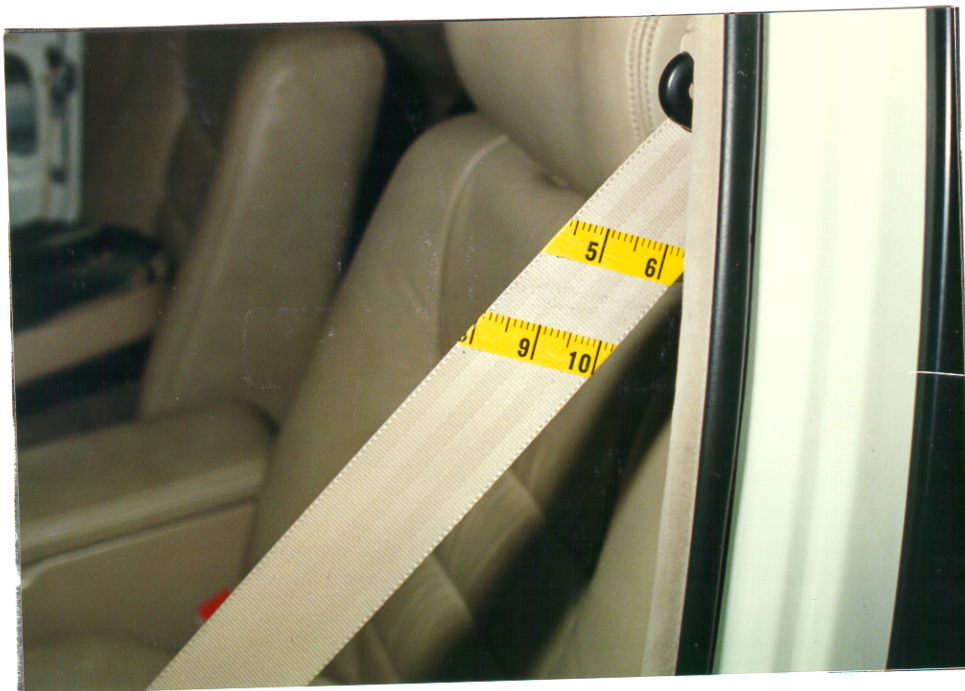
The driver loaded the active 3-point belt system as she initiated her forward trajectory. Her loading force on the shoulder belt webbing produced a black plastic transfer from the B-pillar mounted D-ring. The driver sustained superficial abrasions of the anterior left neck and shoulder from the shoulder belt webbing. The active and passive restraint systems were effective in preventing the driver from contact with additional interior components and potential further injury.

D-Ring Transfer On The Shoulder Belt Webbing From Driver Loading

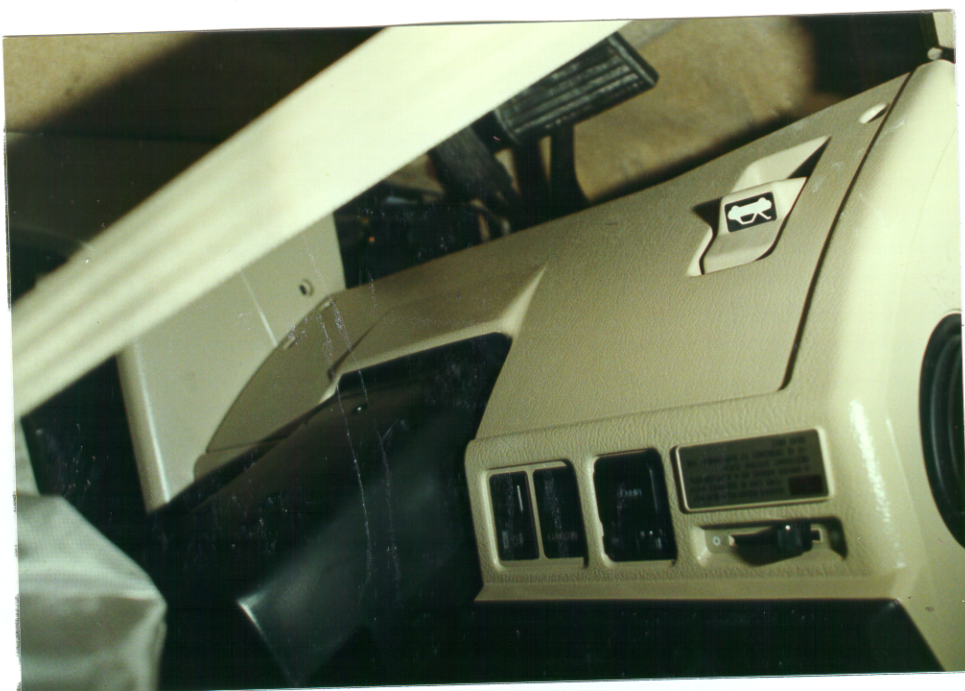
Driver Knee Bolster, No Evidence Of Driver Contact

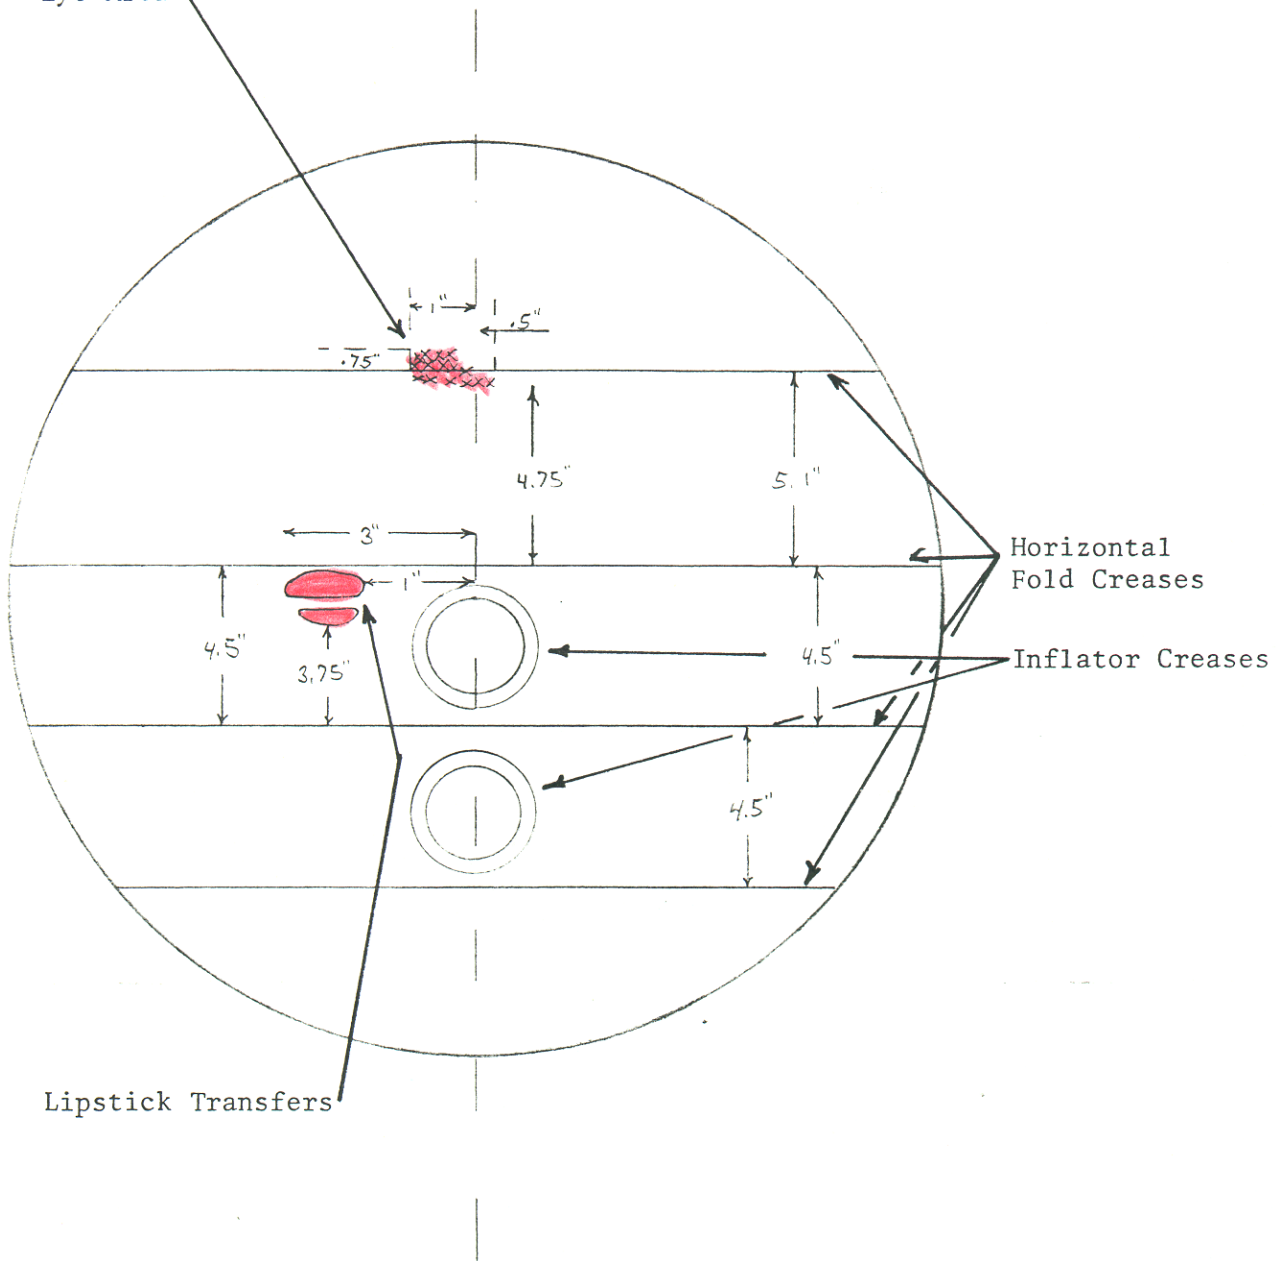
Air Bag Contact Schematic

Makeup Transfers, Possible
Eye Area
